PCI Express System Architecture Book Errata

Errata for First Edition, Second Book Printing

Table 1 lists errata for the PCI Express System Architecture Book, First Edition, Second Printing, dated December 2003 and later printings.

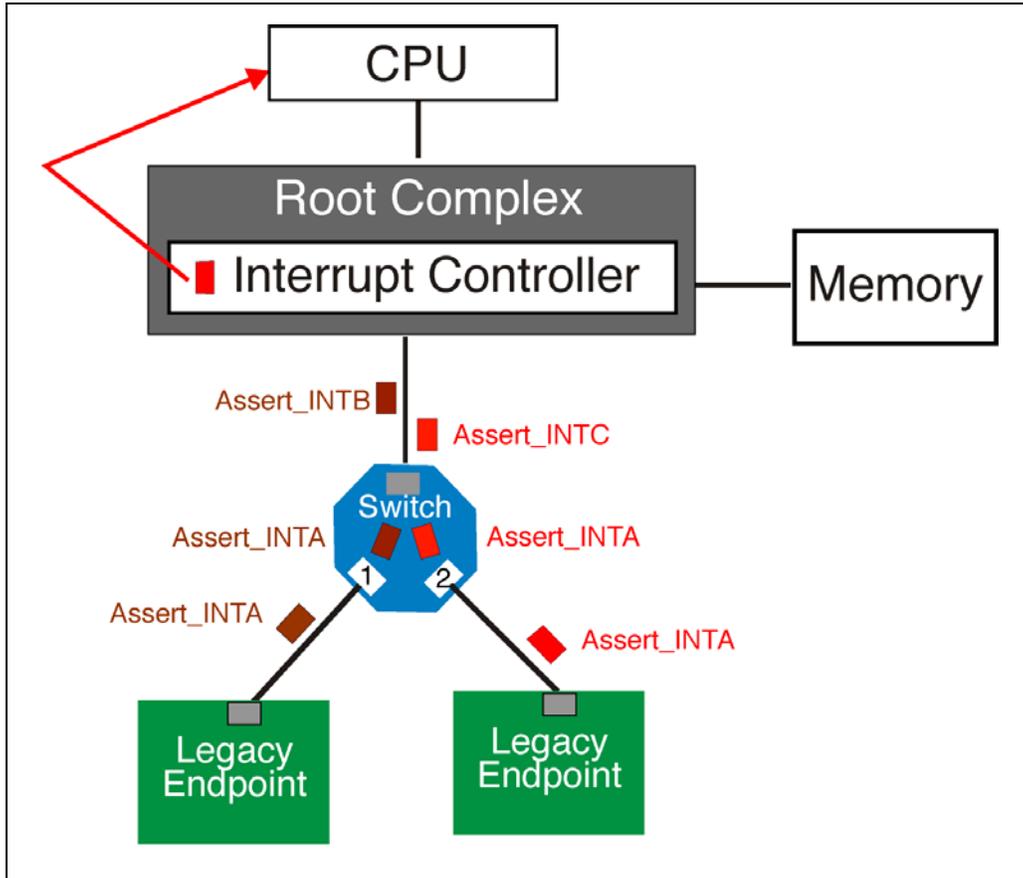
Figure 1: Example of INTx Mapping

INTx Mapping. Switches must adhere to the INTx mapping defined by the PCI specification (See Table 1-1 on page 15 in this document). This mapping defines the virtual connection that exists when interrupts are routed across a PCI-to-PCI bridge. The routing (or mapping) is based on the INTx message type and the source device number. For example, the messages being received on ports 1 and 2 (in Figure 1 on page 16) are both INTA messages. The virtual PCI-to-PCI bridge at each of the ingress ports will map both INTA message to INTA. This is because the configuration device number of both originating Endpoint devices is zero. Table 1-1 shows that interrupts messages coming from Device 0 map to the same INTx message on the other side of the bridge (i.e., internal to the bridge both INTA messages are mapped to INTA). Consequently, the egress port's PCI-to-PCI virtual bridge will also receive these interrupts as INTA messages. However, when the egress port maps the interrupts for delivery on the upstream link, the mapping changes. Assume that the virtual PCI bridge at port 1 is designated device 1 and that port 2 is designated device 2). When consulting the INTx mapping table the INTA interrupt message from Device 1 will be mapped to the INTB message and the INTA message arrive on port 2 will be mapped to the INTC message.

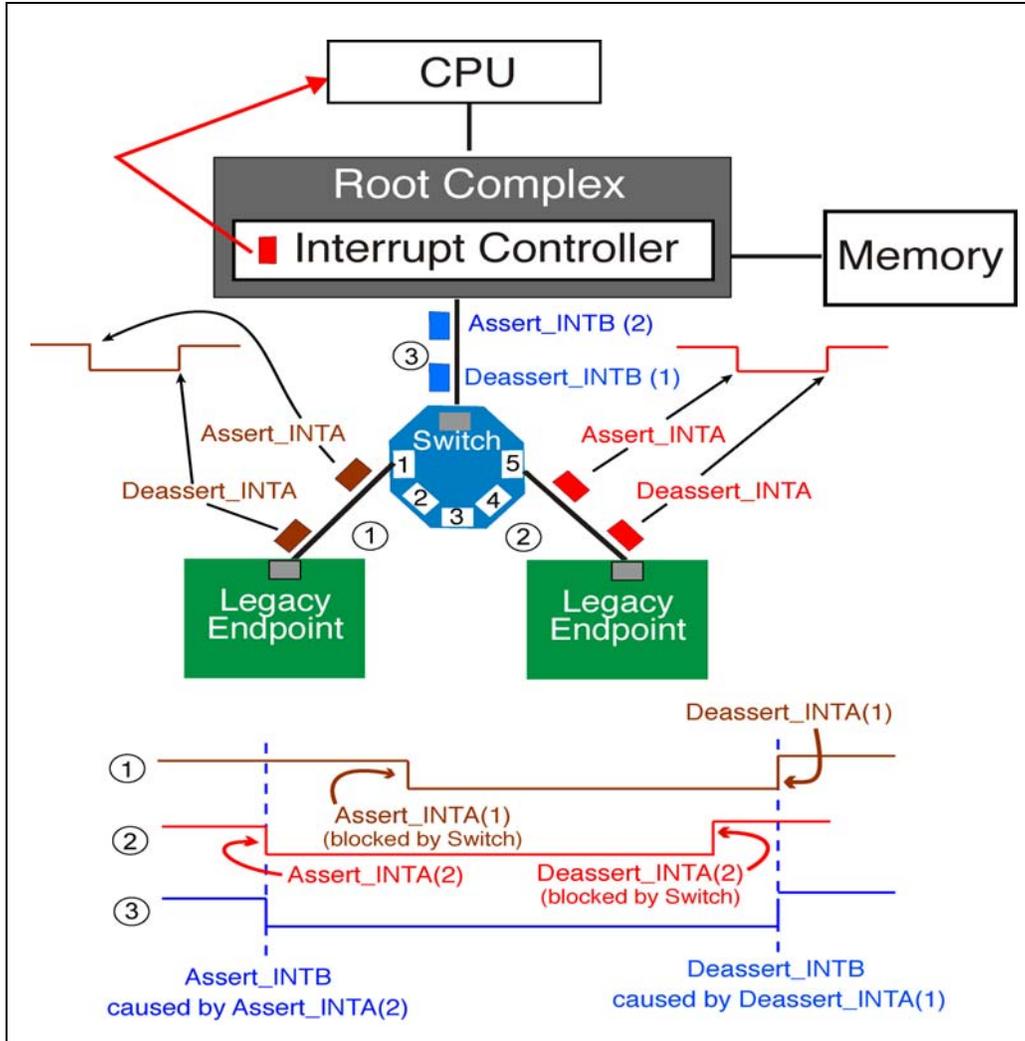
Figure 2: Switch Collapses INTx Message to Achieve Wired-OR Characteristics

INTx Collapsing. In some cases two overlapping INTx messages may be mapped to the same INTx message by the virtual PCI bridge at the egress port, requiring the messages to be collapsed. Consider the following example illustrated in Figure 2 on page 17.

Once again the incoming interrupt message mapping does not change at the ingress port. However, when the egress port maps the interrupt messages for delivery on the upstream link, both interrupts will be mapped as INTB (assuming that the virtual PCI bridge at port 1 is designated device 1 and port 5 is designated device 5). Note that because these two overlapping messages are of the same type they must be collapsed.

Collapsing ensures that the interrupt controller will never receive two consecutive Assert_INTx messages of the same type nor two consecutive Deassert_INTx messages of the same type. This is equivalent to INTx signals being wire-ORed as illustrated in Figure 2.
